Test Report

IPS 7898-80

ISTA 3E PERFORMANCE TEST

DRUMCLIP DC18A RED with TIGHT HEAD BARREL DRUMS

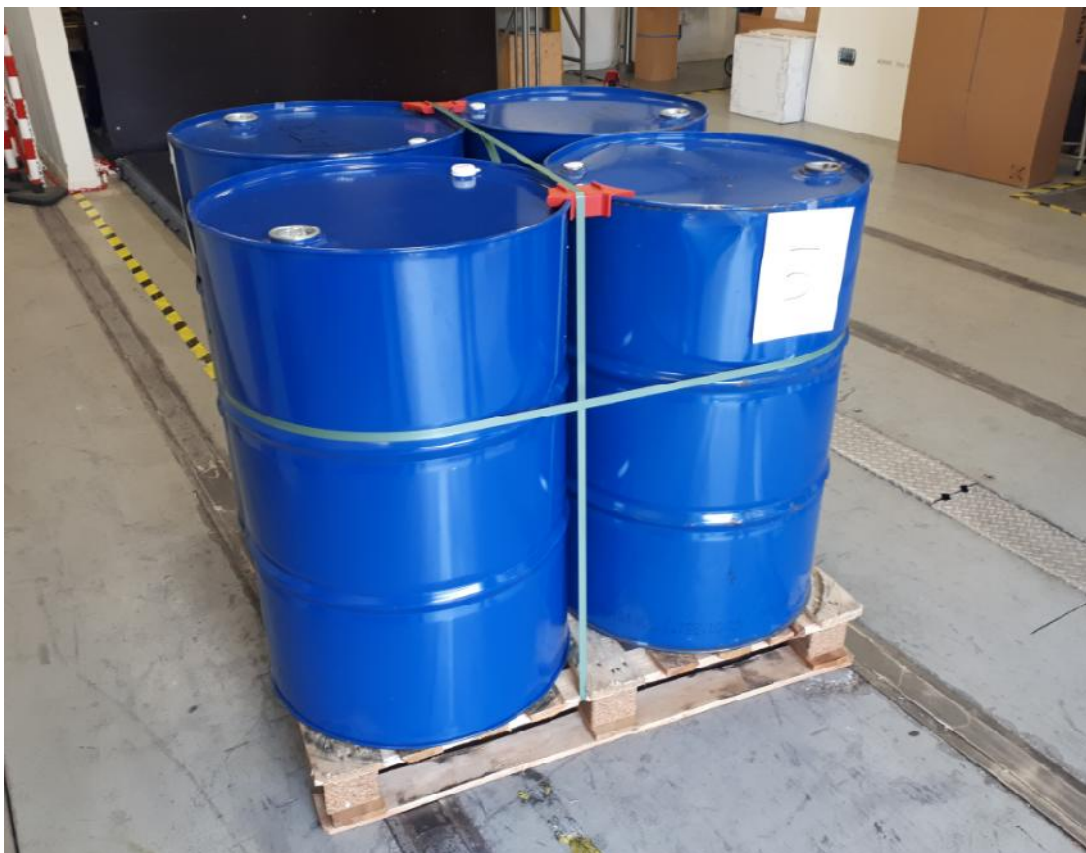
Four Standard Tight Head Barrel Drums 200L are placed on a pallet and secured with two Drumclips and secured with two polyester lashings.

Figure 1. Test configuration

Item	Remark
Standard Tight Head Barrel Drums 200L. Quantity: 4	Drums fully filled with water. Used condition.
Pallet type: CP-9	Chemie Pallet, 1140x1140x156mm, used condition.
Lashing: Signode Tenax 2040 Strapping. Quantity: 2	Polyester Strapping 16mm, thickness 0,89mm Location of the strapping shown in Figure 1.
Drumclip type: DC18A RED	Quantity used: 2x

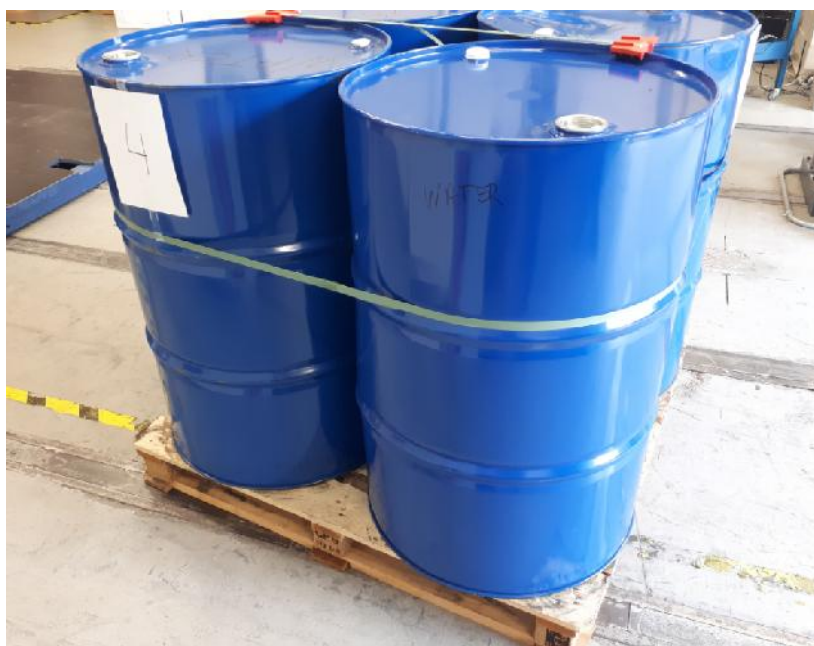
Identification of sides (according to ISTA 3E) see Figure 2.

Figure 2. Faces of DUT identified.

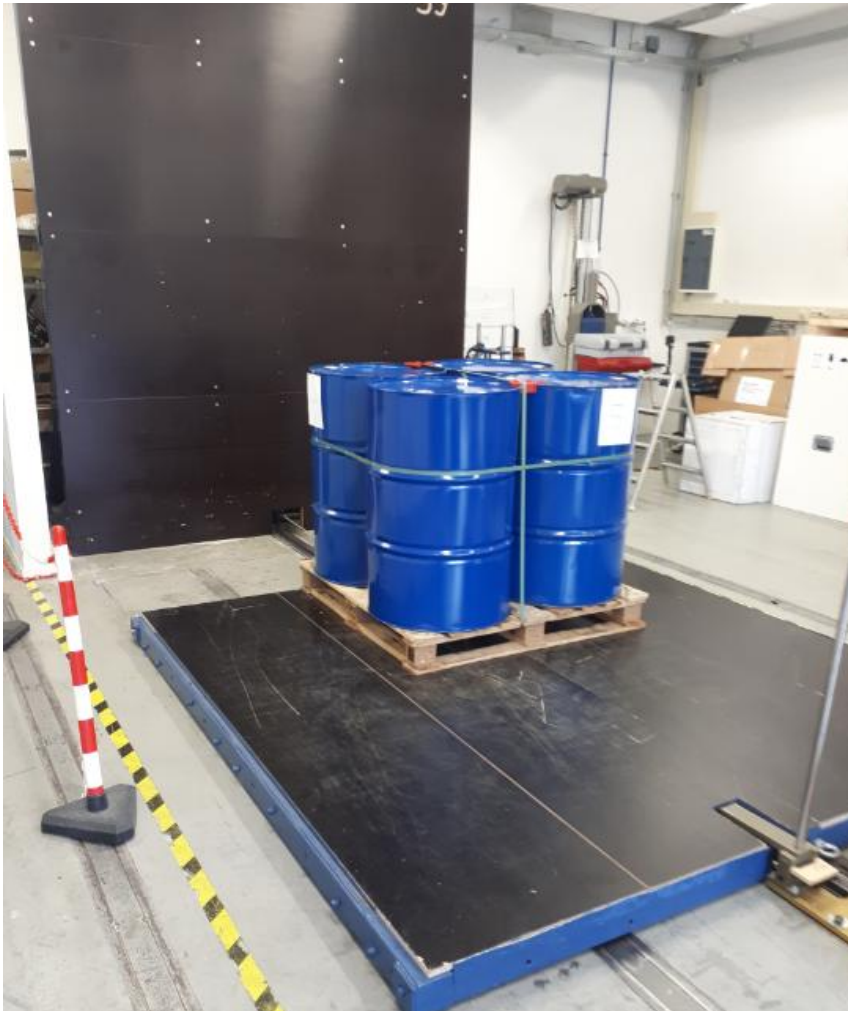
The DUT will be exposed to horizontal impacts in order and under the conditions as stated in the table below.

Sequence No.	Specific Face	Impact Speed
1	Face 6	1,2 m/s
2	Face 5	1,2 m/s
3	Face 2	1,2 m/s
4	Face 4	1,2 m/s

Horizontal impact testing will be performed with the IPS Technology horizontal impact tester.

Figure 3.DUT on horizontal impact tester.

The horizontal impact test is executed according test plan. No remarkable event occurred before, during or after performance of this Test Sequence. The impact speed is measured at 1,2 m/s. See for the speed graph Appendix D.

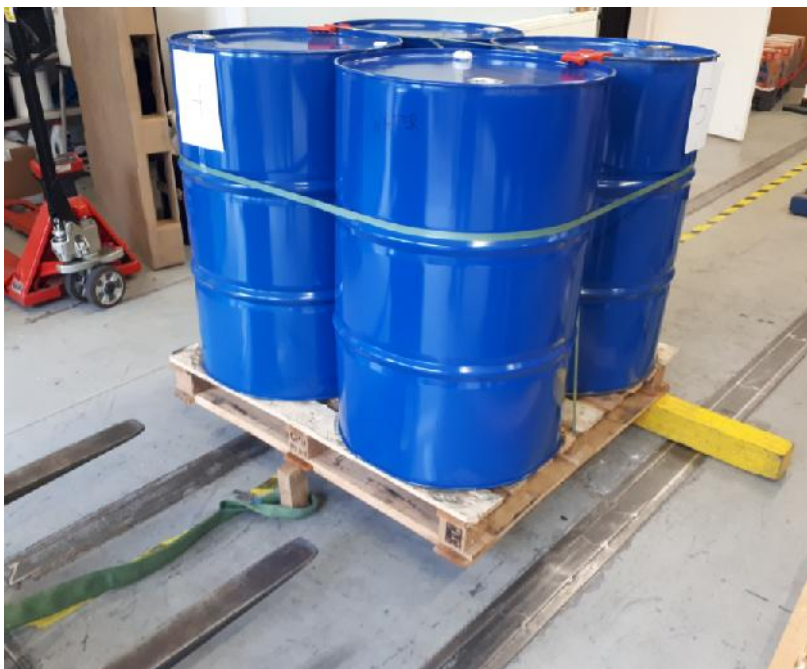
Based on the mass of the DUT >230kg the drop height is set on 150mm.
During the drop test, the side opposite to the drop side is supported by a timber with a height of 90mm.
The DUT is exposed to rotational edge drops in order and under the conditions according to the table below.

Sequence No.	Specific edge	Drop height
1	Edge 3-6	150mm
2	Edge 3-2	150 mm
3	Edge 3-5	150 mm

Figure 4. Set-up Rotational Edge Drop Test

The Rotational Edge Drop Sequence is executed according test plan. No remarkable event occurred before, during or after performance of this Test Sequence.

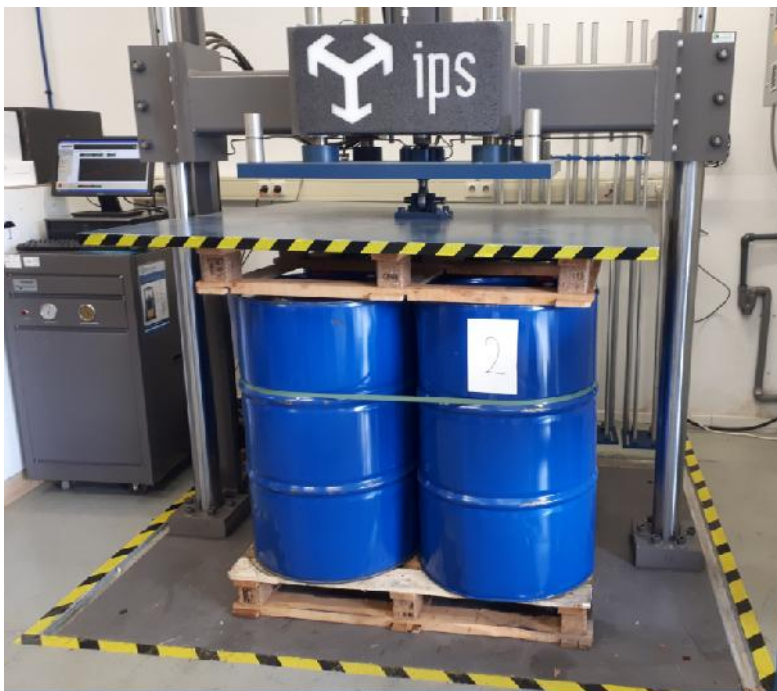
The DUT will be exposed to a 'Machine Apply and Release' compression test according to the ISTA 3E test protocol. For the calculation for compression (Apply and Release method) the formula $AR = \{[Wt \times (S-1) + (Wt/L) \times (L-1)] \times F - (Wt / L) (L-1)\} \times 1,4 \times 9,8$ is applicable.

The test will be performed with an additional (empty) pallet on top of the DUT. This will be done in order to simulate the reality of stacking load. Figure is showing the compression test setup.

Figure 5. Test set-up Compression Test

No remarkable event occurred before, during or after the Test Sequence. A screenshot of the compression test is shown in a graph in Appendix E.

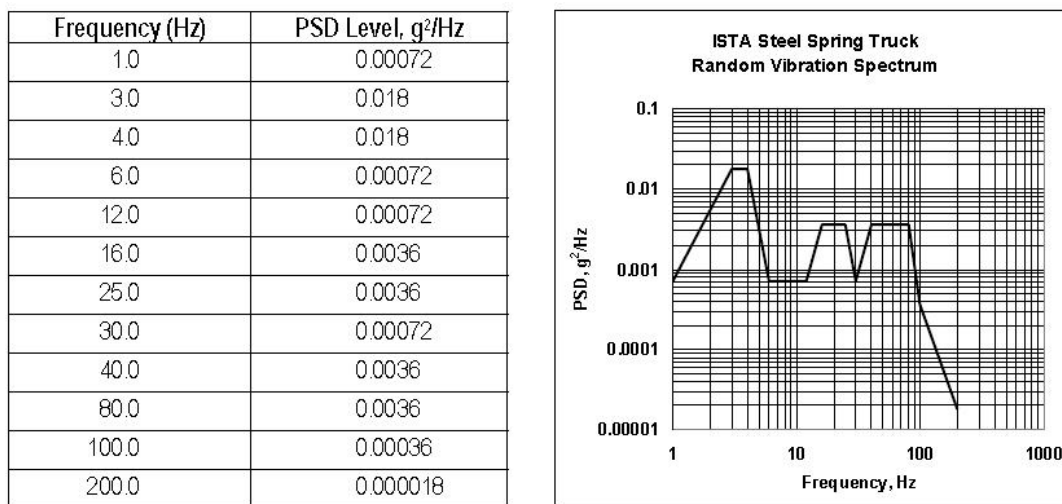
The Power Spectral Densities ISTA Steel Spring Truck profile is given in the figure below.

Figure 2. Power Spectral Densities – Steel Spring Truck Random Vibration

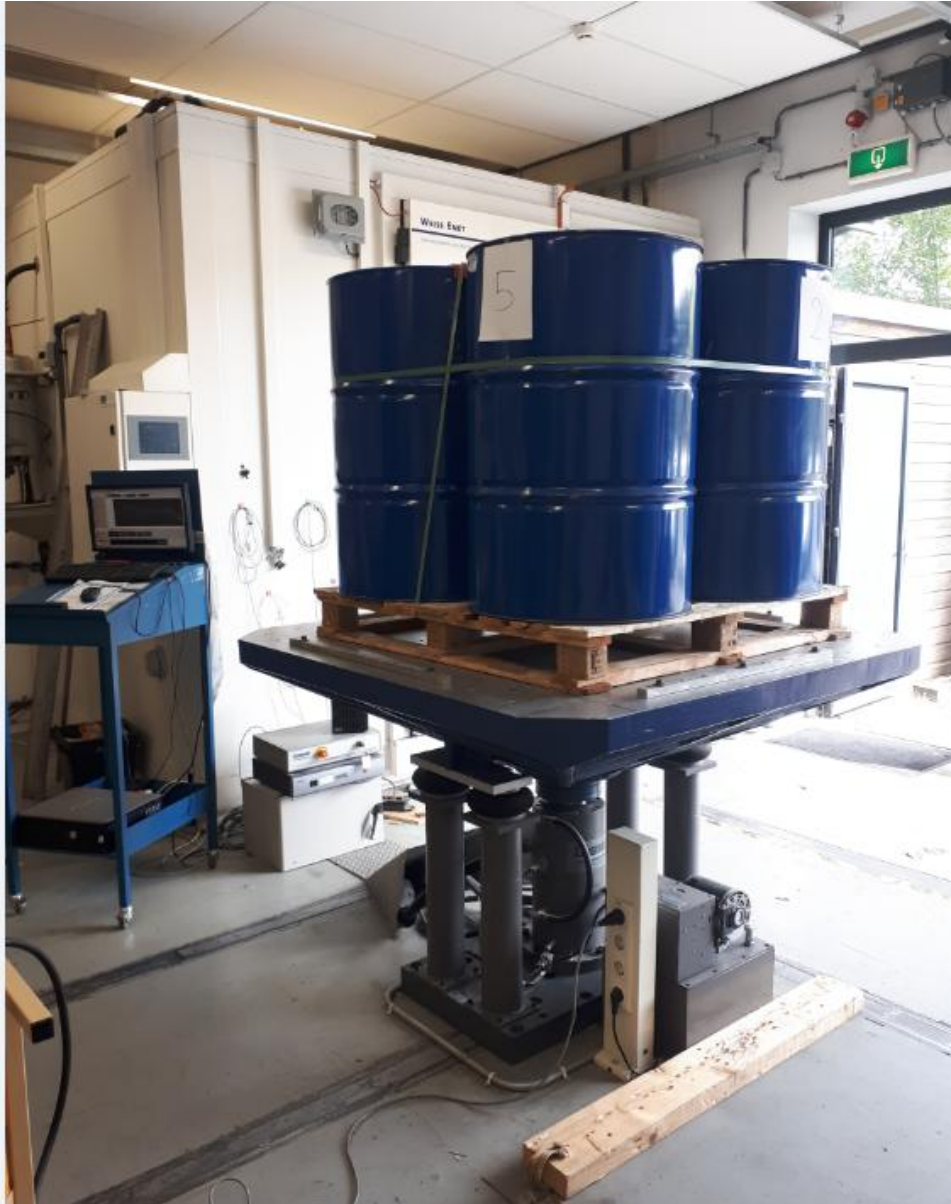
The DUT will be exposed to a vibration test without compressive load, to simulate transport vibrations. The test is performed under 'loose load' conditions. For the test setup see Figure .

The duration of 60 minutes will be equivalent to a transport of 480km.

Orientation	Vibration Profile acc.	Duration
Face 3 down (bottom face)	ISTA Steel Spring Truck	60 minutes

Figure 6. Test setup for vibration test

The vibration test is executed according test plan. No remarkable event occurred before, during or after performance of this Test Sequence. A screenshot of the PSD during the test is shown in Appendix F.

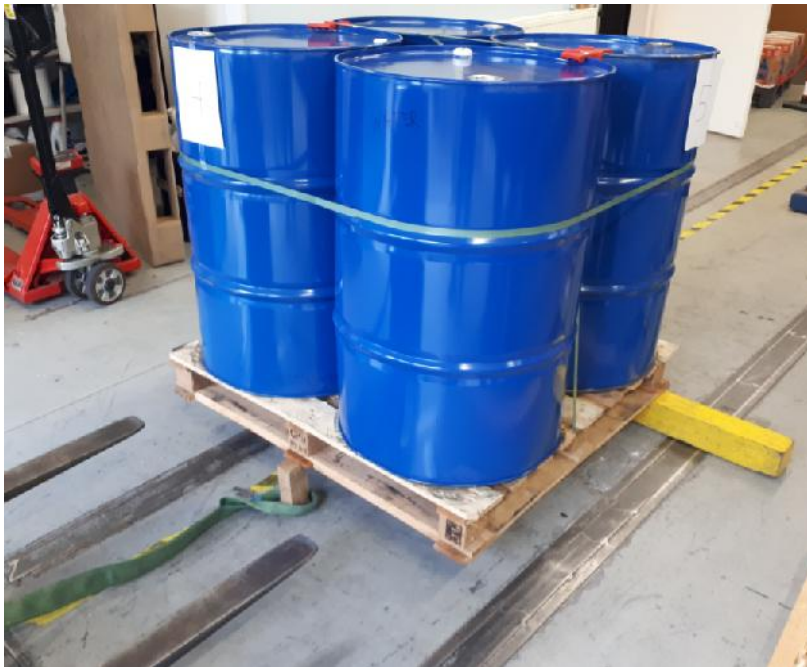
Based on the mass of the DUT >230kg the drop height is set on 150mm.
During the drop test, the side opposite to the drop side is supported by a timber with a height of 90mm.
The DUT is exposed to rotational edge drops in order and under the conditions according to the table below.

Sequence No.	Specific edge	Drop height
1	Edge 3-6	150mm
2	Edge 3-2	150 mm
3	Edge 3-5	150 mm

Figure 7. Set-up Rotational Edge Drop Test

The Rotational Edge Drop Sequence is executed according test plan. No remarkable event occurred before, during or after performance of this Test Sequence.

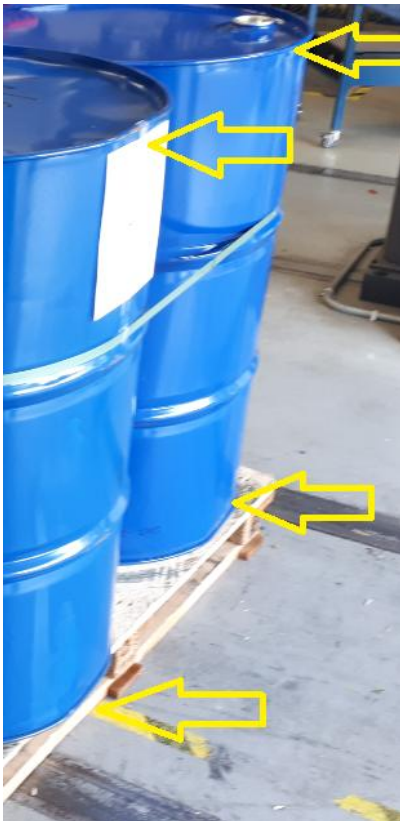
After execution of the complete test cycle no remarkable – unexpected damages to the DUT and its components could be found. The expected damage to the drums could be found only on face 4. The condition of the CP-9 pallet was still in useable condition.

Figure 8. Damage to drums; only face 4.

Examination of the condition by personnel of Geba Innovations B.V. of the Drumclips after the test showed no visible damage or wear.

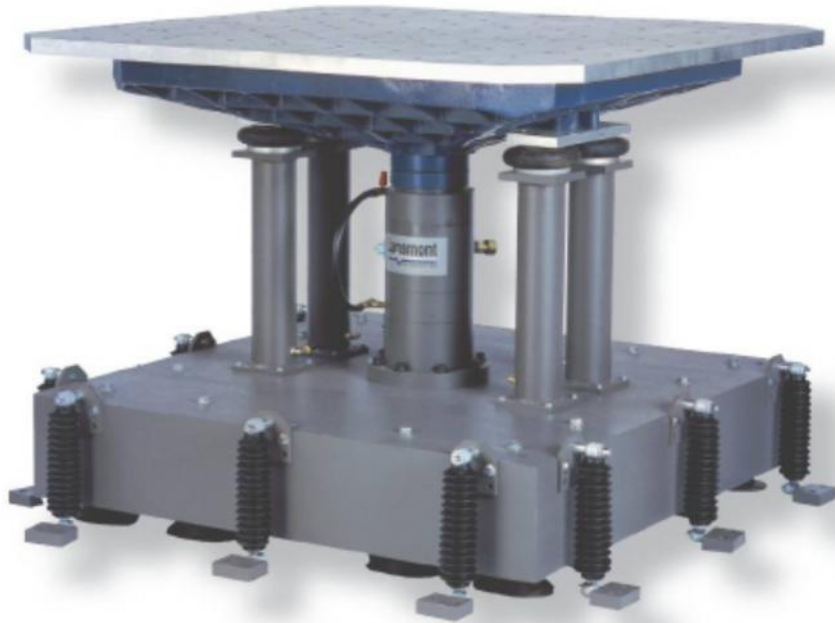
- Manufacturer : Lansmont model 10000 TTV II
- Max. specimen size : 152 x 152 cm
- Max. specimen weight : 2200 kg
- Max. amplitude (peak to peak) : 6,4 cm
- Frequency-range : 3 - 300 Hz
- Frequency-rang at max. load : 3 - 200 Hz
- Acceleration range : 0 - 8 g
- Max. acceleration at max. load : 2 g
- Automatic displacement or acceleration control
- Automatic sweep generator and random vibration facilities (Lansmont TouchTest Vibration system)
- Accelerometer

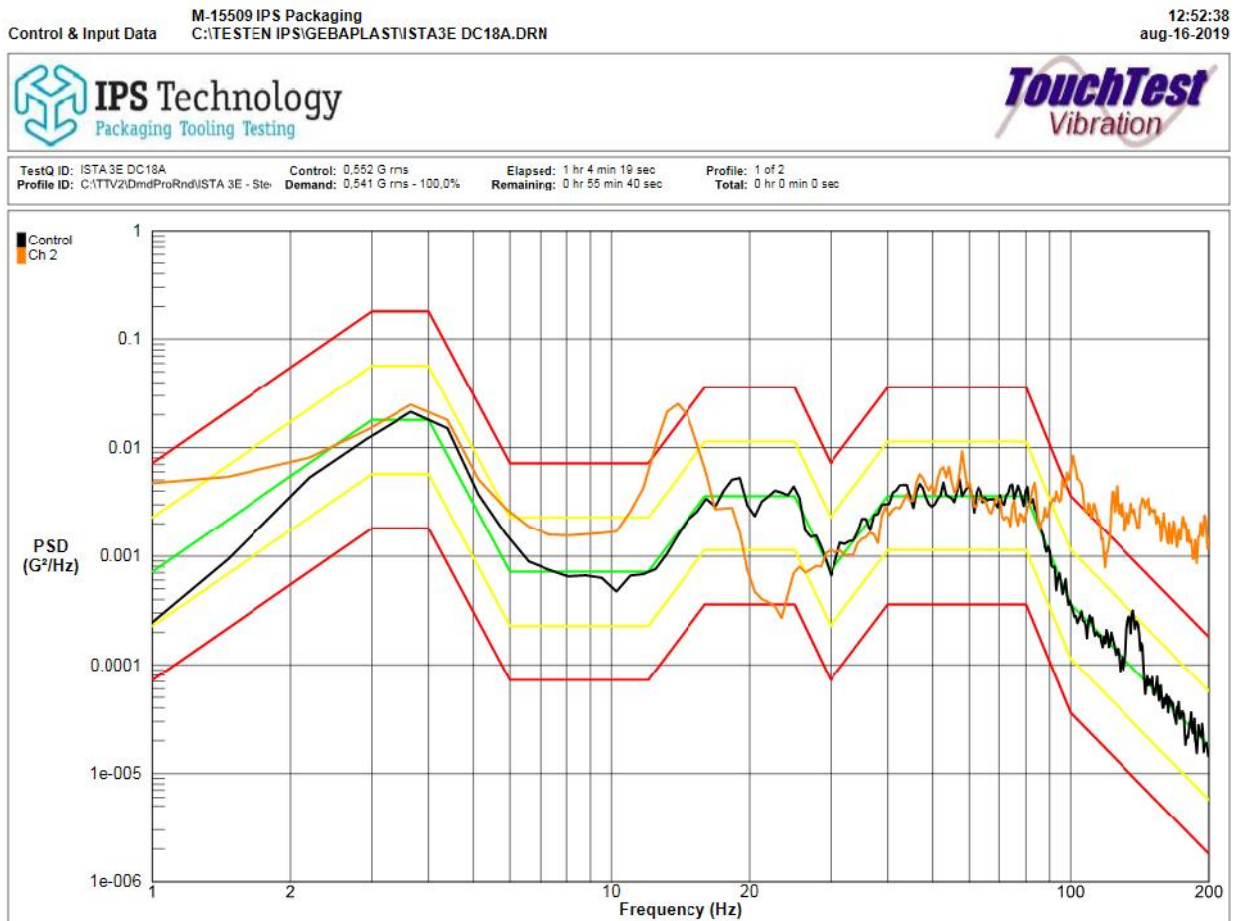
Figure 12. Power Spectral Densities - ISTA Steel Spring Truck Random Vibration; 1 hr 4min.

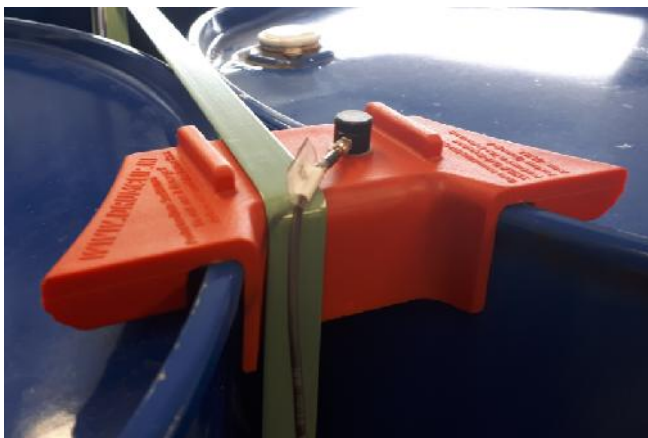
Figure 13. Location accelerometer Ch2. for response monitoring (examination only)
